## Saguaro National Park

# Protecting Riparian Areas through Hydrological Monitoring

**Final report to Western National Parks Association**  
Grant #07-11

Saguaro National Park, Tucson, Arizona  
September 10, 2008

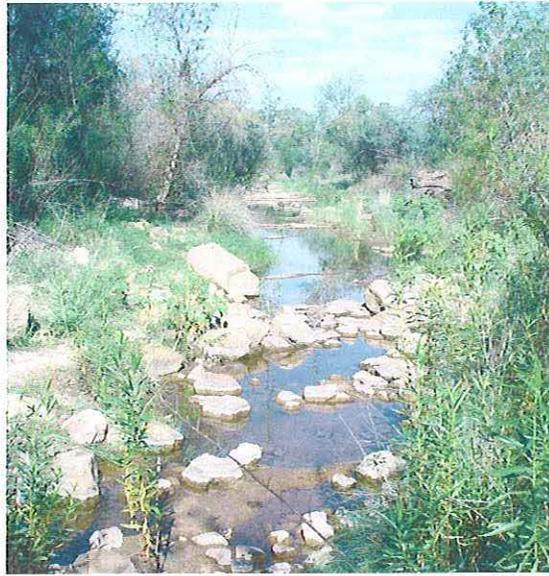
Figure 1. The middle reach of Rincon Creek, along the southern boundary of Saguaro National Park, Rincon Mountain District. Unlike most streams in the park, the middle reach of Rincon Creek flows along a broad valley floor.

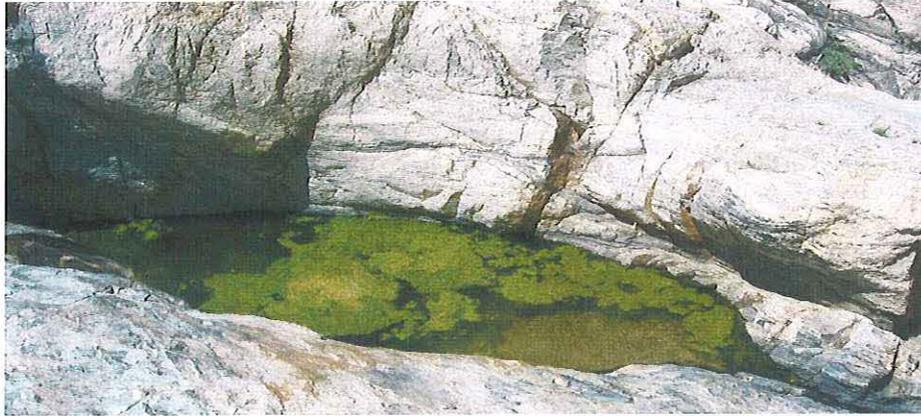
Figure 3. Pool 8 in Wildhorse Canyon, a typical tinaja in Saguaro National Park.

Tinaja geomorphology. During the dry (May-July) pre-monsoon season in 2007, we re-surveyed sediment volume in 24 tinajas (Ratzlaff 2007). Sedimentation varied among tinajas and canyons, but there was an increase in sedimentation in 19 of the 24 pools surveyed (Table 1). Sediment in tinajas increased in all canyons surveyed except for Loma Verde Canyon, where 4 of the 6 pools surveyed had less sediment volume in 2007 than in 2005-2006. However, 3 pools where sediment increased had been excavated in an experimental lowland leopard frog habitat restoration project following the 2005-2006 surveys. Figures 3-4 show a photo of a typical tinaja and output from survey data.

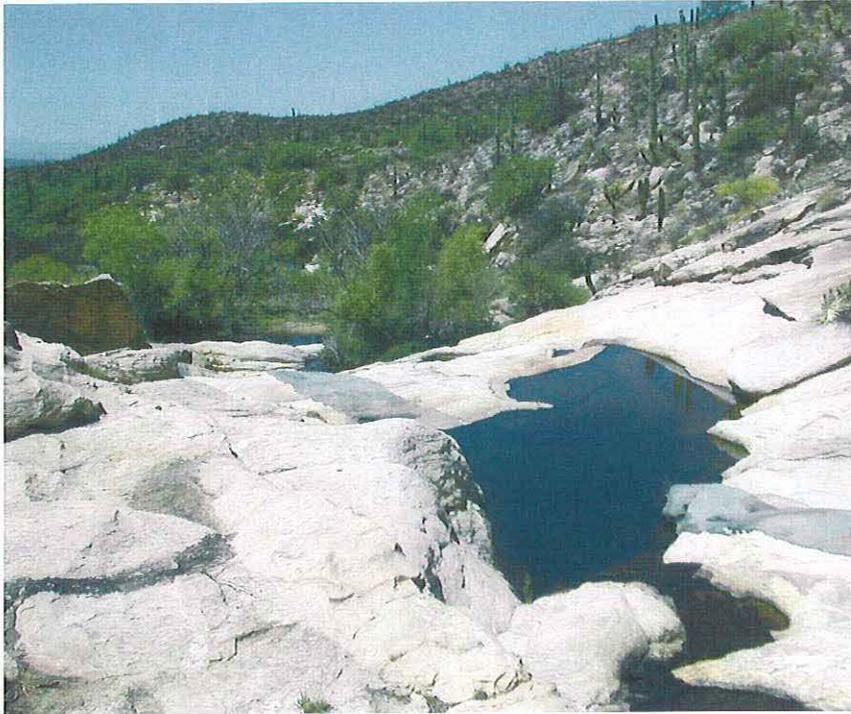
Figure 5. Pool 1d, in the “Madrona Pools” of Chimenea Creek, Saguaro National Park.

Hydrological monitoring using volunteers. Of the two pools in Chimenea Creek where we recorded weekly water levels, pool 1d (Figure 5) contained water throughout the period. Pool 1l dried during the spring of 2006 but contained water most of the time and water levels in both pools appeared to be strongly correlated (Figure 6).

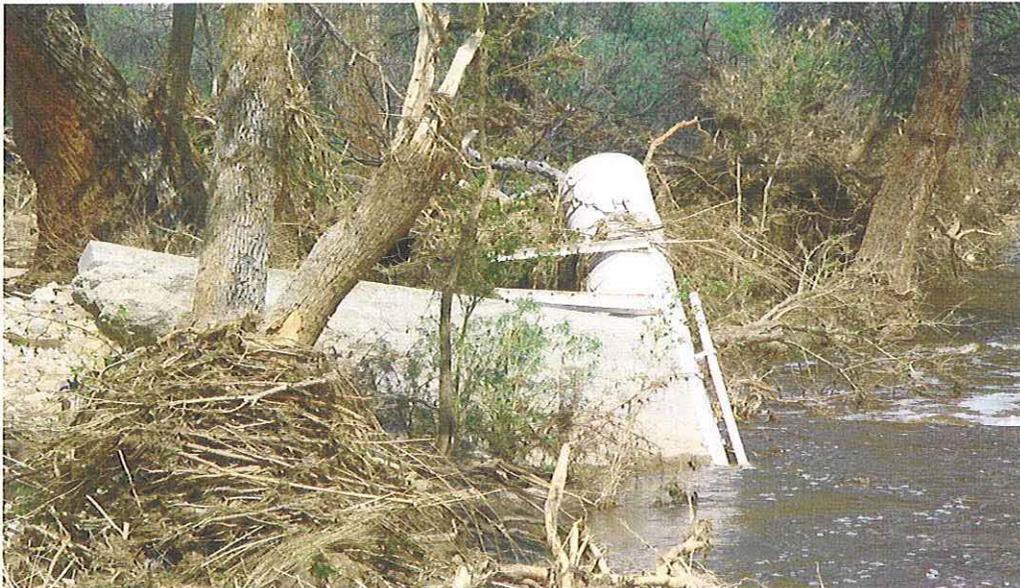
Figure 8. USGS gage in Rincon Creek, which stood for 53 years before the 2006 flood.

Rainfall records indicate that the most intense part of the storm was centered over the Happy Valley saddle, which received nearly 4 in. of rain during the night of July 31, 2006. However, Rincon Creek received significant rainfall in all of its tributaries both at high and low elevations. The estimated maximum discharge in Rincon Creek during the flood was calculated to be approximately 15,000 cfs (USGS and NPS unpublished data), higher than for Chimenea Creek, a tributary. Data from the flood are summarized in Perger (2008b), a lay report that included photos (Figure 8) from park staff and neighbors and was distributed to interpretive and other staff.
